# Manhole Inspection Summary

Manhole # S47KK\_030MH

Insp Date: **6/19/08 12:41 PM**

**Location** Address: **Gay** Cross Street: **Patterson Park**

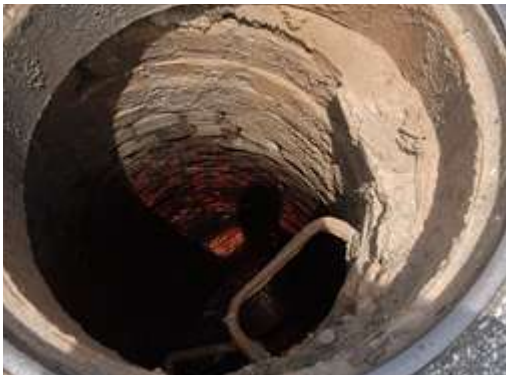
Defect 2

**Frame** Offset: **4** (in.) Condition: ☒ Sound ☐ Cracked ☐ Leaks

offset frame

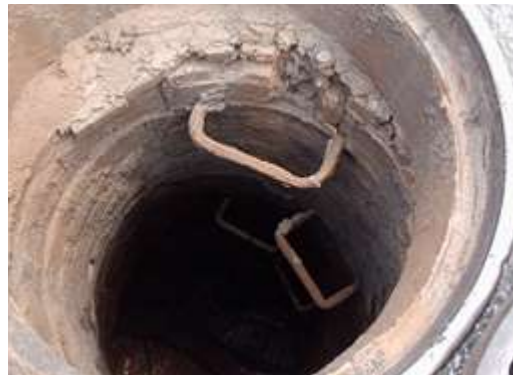
Defect 1

**Chimney / Frame Adjustment** ☒ Exists Material: **Brick** ☐ Parged Height: **24** (in.)  
Condition: ☐ Sound ☐ Cracked ☐ Root Intrusion ☒ **Loose Brick** ☐ Deteriorated  
Infiltration: ☐ None ☒ **Joint** ☐ Cracks ☒ **Mortar** ☐ Roots ☐ Wall

Infiltration, Loose bricks

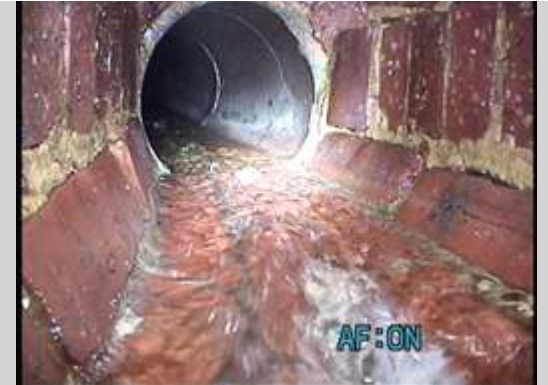
12 O'Clock Outflow

8 in. Circular Gravity Sewer  
Pipe Out @ 12 O'Clock

Pipe Height: **8.4** (in.) Rod and Bar (Angled)  
Pipe Material: **Clay** ☐ Pipe Lined  
Invert Depth: **14.70** (ft.) Flow Characteristics: **Fast**  
Deposits: ☒ None ☐ Mud ☐ Sludge ☐ Debris ☐ Grease  
Silt Depth: (in.) Deposits Extent:  
Infiltration: **None** Pipe Seal Cond: **Sound**

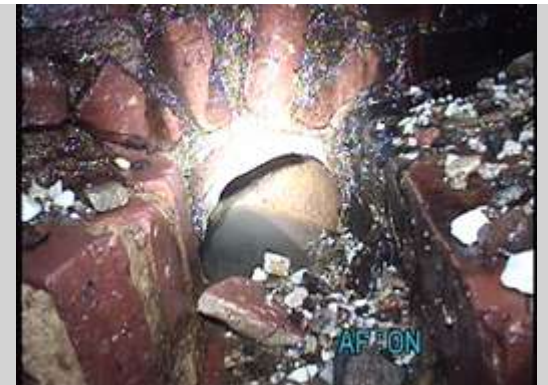
3 O'Clock Inflow

6 in. Circular Gravity Sewer  
Pipe In @ 3 O'Clock

Pipe Height: **6** (in.) Rod and Bar (Angled)  
Pipe Material: **Clay** ☐ Pipe Lined  
Invert Depth: **14.50** (ft.) Flow Characteristics: **Fast**  
Deposits: ☒ None ☐ Mud ☐ Sludge ☐ Debris ☐ Grease  
Silt Depth: (in.) Deposits Extent:  
Infiltration: **None** Pipe Seal Cond: **Sound**

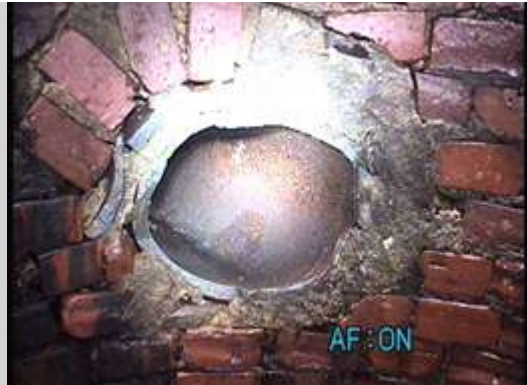
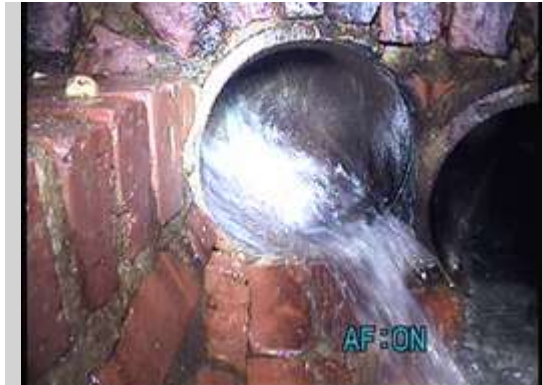
6 O'Clock Inflow

Pipe In @ 6 O'Clock

Drop In @ 6 O'Clock

Drop: <b>Inside</b>	Rod and Bar
Angled: <b>Yes</b>	Reading: <b>13.30</b> (ft.)
	Inv Depth: <b>14.30</b> (ft.)
Drop Condition: <b>Open</b>

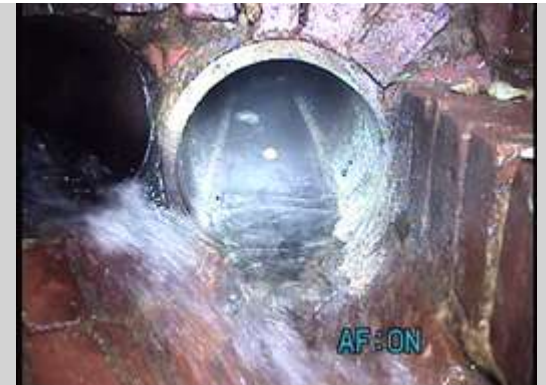
7 O'Clock Inflow

Pipe In @ 7 O'Clock

Infiltration: **None** Pipe Seal Cond: **Sound**
